# Certificate of Inspection

## Z12345-xxx

Terrene, Inc.  
**Z12345-xxx**

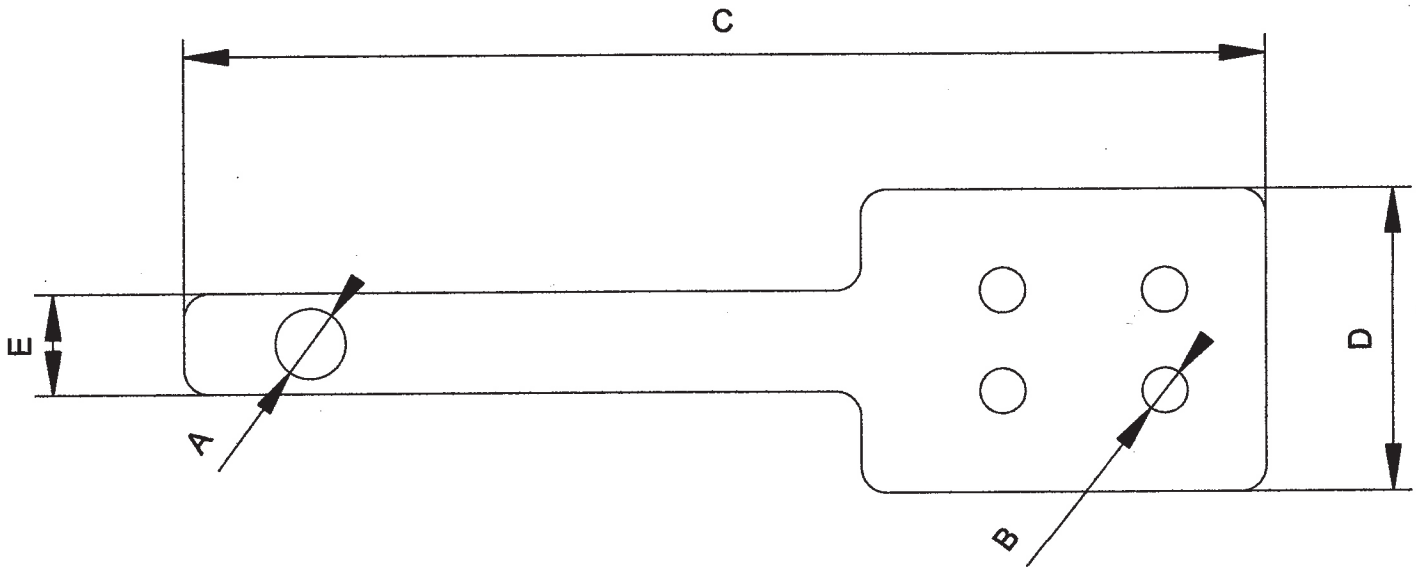
Filepath:	H11326-153_x50.plr			
Customer:	Terrene's Awesome Client			
Operator:	P. Hensley			
Inspection Date:	██████████			
Works Order No:	42337			
Customer Order No:	TR-123			
Part No:	Z12345-xxx			
Customer Part No:	Z12345-xxx			
Report Summary:	Items Passed: 5	Items Failed: 0	Items Missing: 0	Extra Holes: 0
Part Thickness:	Nominal: 0.16	Actual: 0.16	Deviation: 0

Name	Entity	Datum	Dimension	Nominal	Actual	Deviation	Tolerance	Status
A	Circle	Circle	Dia	0.348	0.34713	-0.00087	+0.006/-0.024	Pass
B	Circle	Circle	Dia	0.2235	0.22346	-0.00004	+/-0.005	Pass
C	Intersection	Intersection	Dist	5.34448	5.34078	-0.0037	+/-0.01	Pass
D	Intersection	Intersection	Dist	1.5	1.49732	-0.00268	+/-0.01	Pass
E	Intersection	Intersection	Dist	0.5	0.49718	-0.00282	+/-0.01	Pass
